**António Pinho<sup>1</sup>, Luís Lopes<sup>2</sup>, Isabel Duarte<sup>3</sup>, Pedro Nogueira<sup>4</sup>**  
 1 GeoBioTec Research Centre, FCT, Department of Geosciences, University of Évora, Portugal; (e-mail: apinho@uevora.pt)  
 2 Geophysics Centre of Évora, FCT, Department of Geosciences, University of Évora, Portugal; (e-mail: lopes@uevora.pt)  
 3 GeoBioTec Research Centre, FCT, Department of Geosciences, University of Évora, Portugal; (e-mail: iduarte@uevora.pt)  
 4 Geology Centre of Oporto Univ., FCT, Department of Geosciences, University of Évora, Portugal; (e-mail: pmn@uevora.pt)

## 1. INTRODUCTION

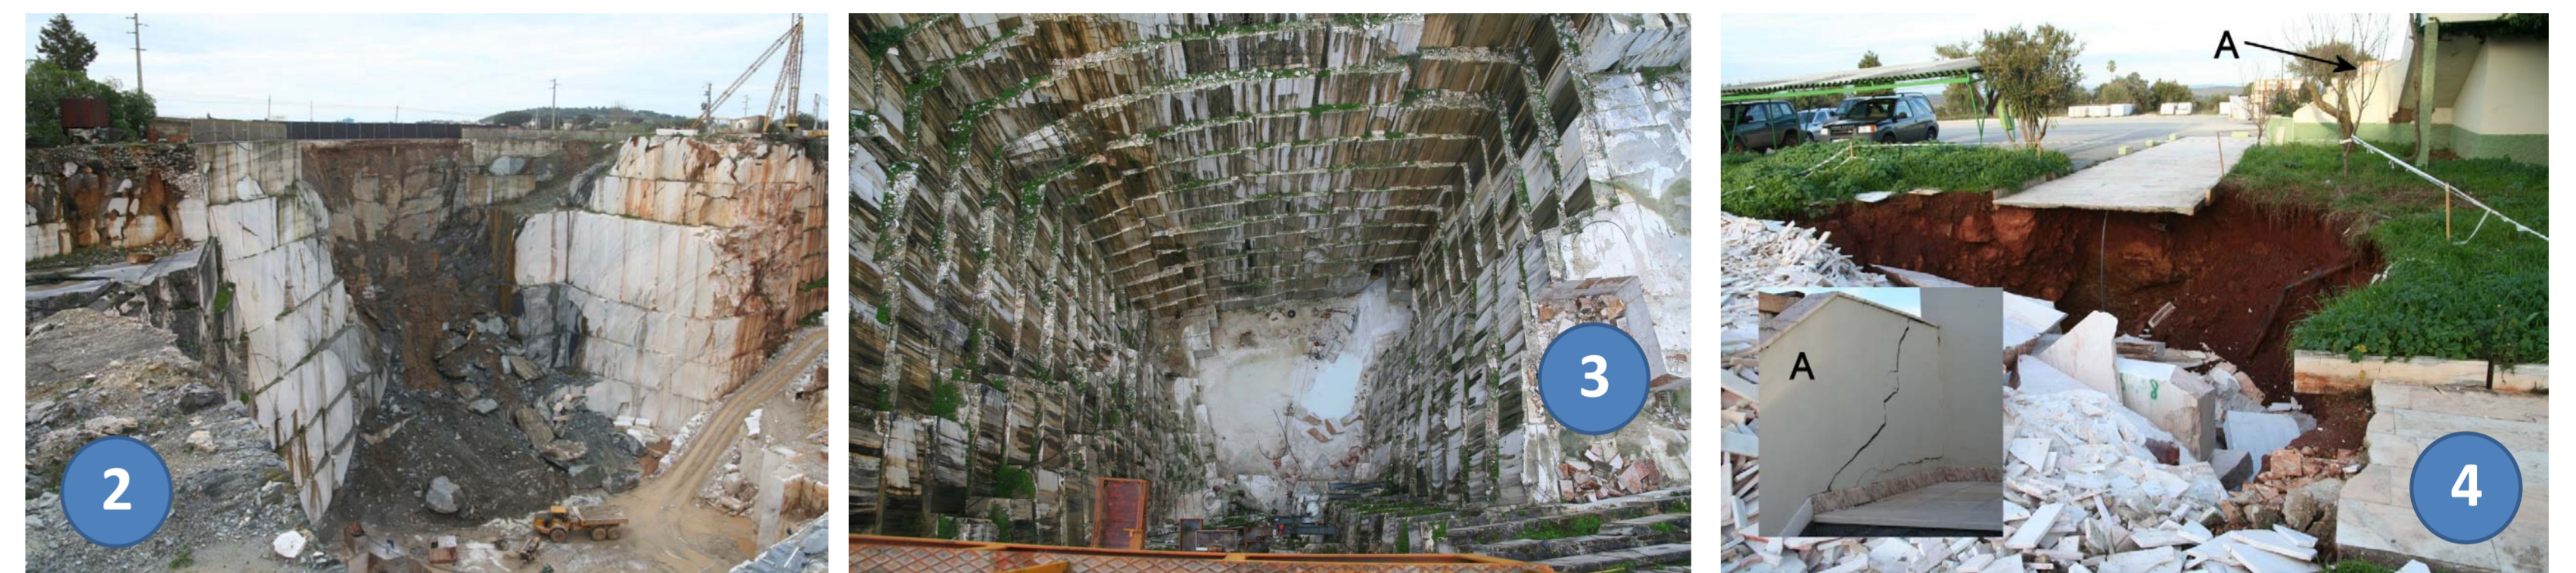
## Panoramic view of the southwestern limb of the Estremoz anticline

**Figure 2.** Rock fall of the southwest slope of the quarry induced, mainly by the effect of the water pressure within the discontinuities. This accident also has even cut a road whose profile is visible on the top of the slope. This quarry is located at point 2 in Figure 1.

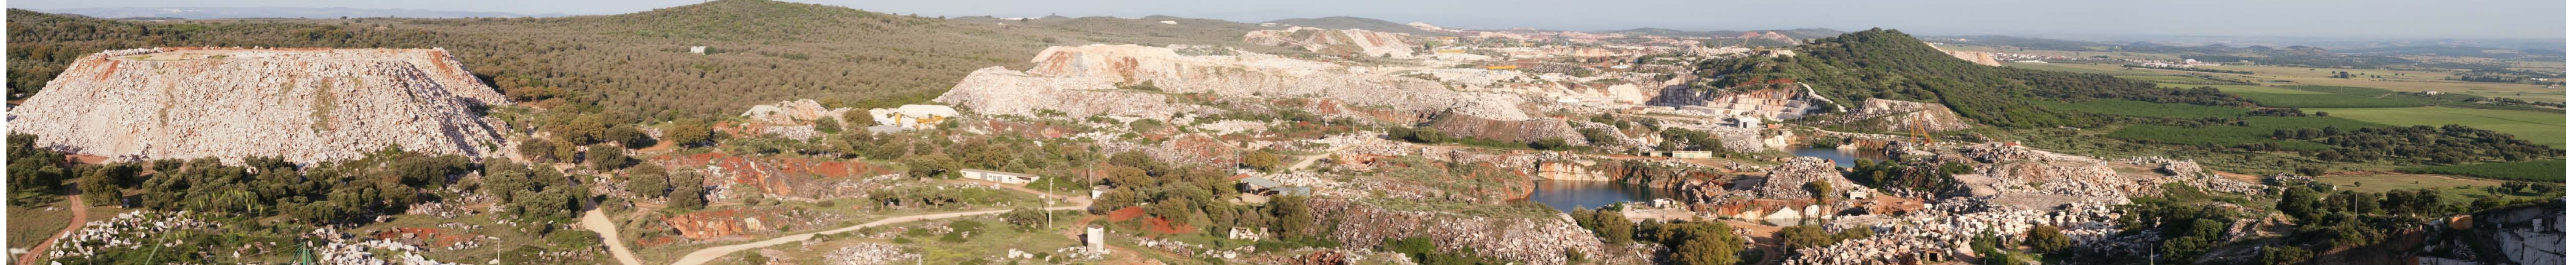
**Figure 5.** Southwest face of the quarry with the main discontinuities sets: A – open vertical discontinuity associated with karst cavity oriented N-S; B – planar discontinuity with orientation 50/072. The masses highlighted in gray are to be removed. This quarry is located at point 1 in Figure 1.

A stability analysis was carried out of the southwest slope of quarry 5145 (point 1, see Figures 1 and 5). This study aimed to evaluate the problem of possible instability of the slope that corresponds to the southwest limit of the referred quarry, based on the geological and structural data of the rock mass that were collected on the site. The assessment of **slope stability** in study was considered fundamental due to the possibility that it may affect adjacent properties between Borba and Vila Viçosa, particularly the Plácido Simões quarry located to the east, and even the National Road EN255, due to their proximity to the slope.

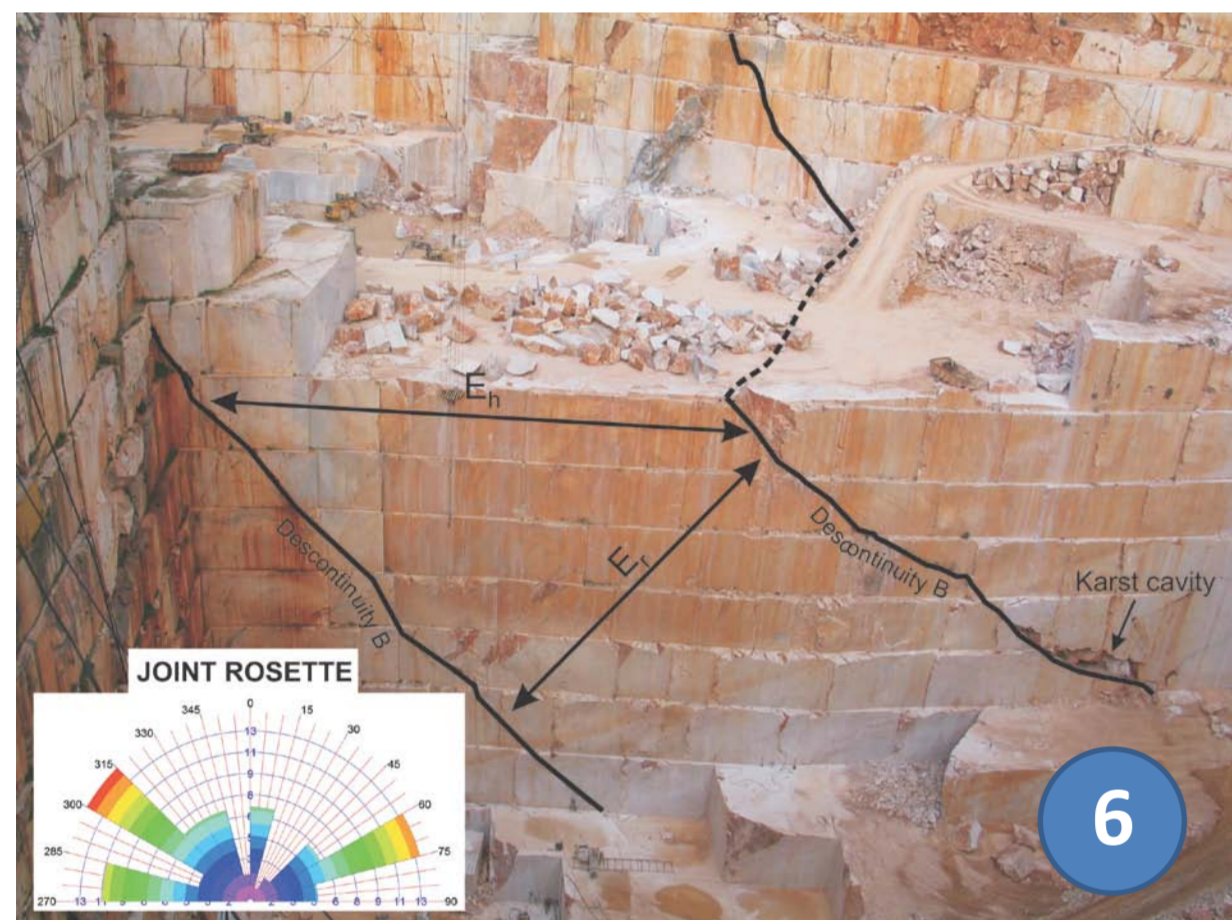
**Figure 6.** View to NW, which identifies the intersection of two discontinuities in set B. Horizontal (Eh) and normal (Er) spacing are indicated, and despite being apparent, they are very close to the actual spacings. On the right is possible to see the development of a karst depth, which demonstrates the unpredictable nature of these structures. A joint rosette inserted shows the joint sets identified in the quarry. This quarry is located at point 1 in Figure 1.

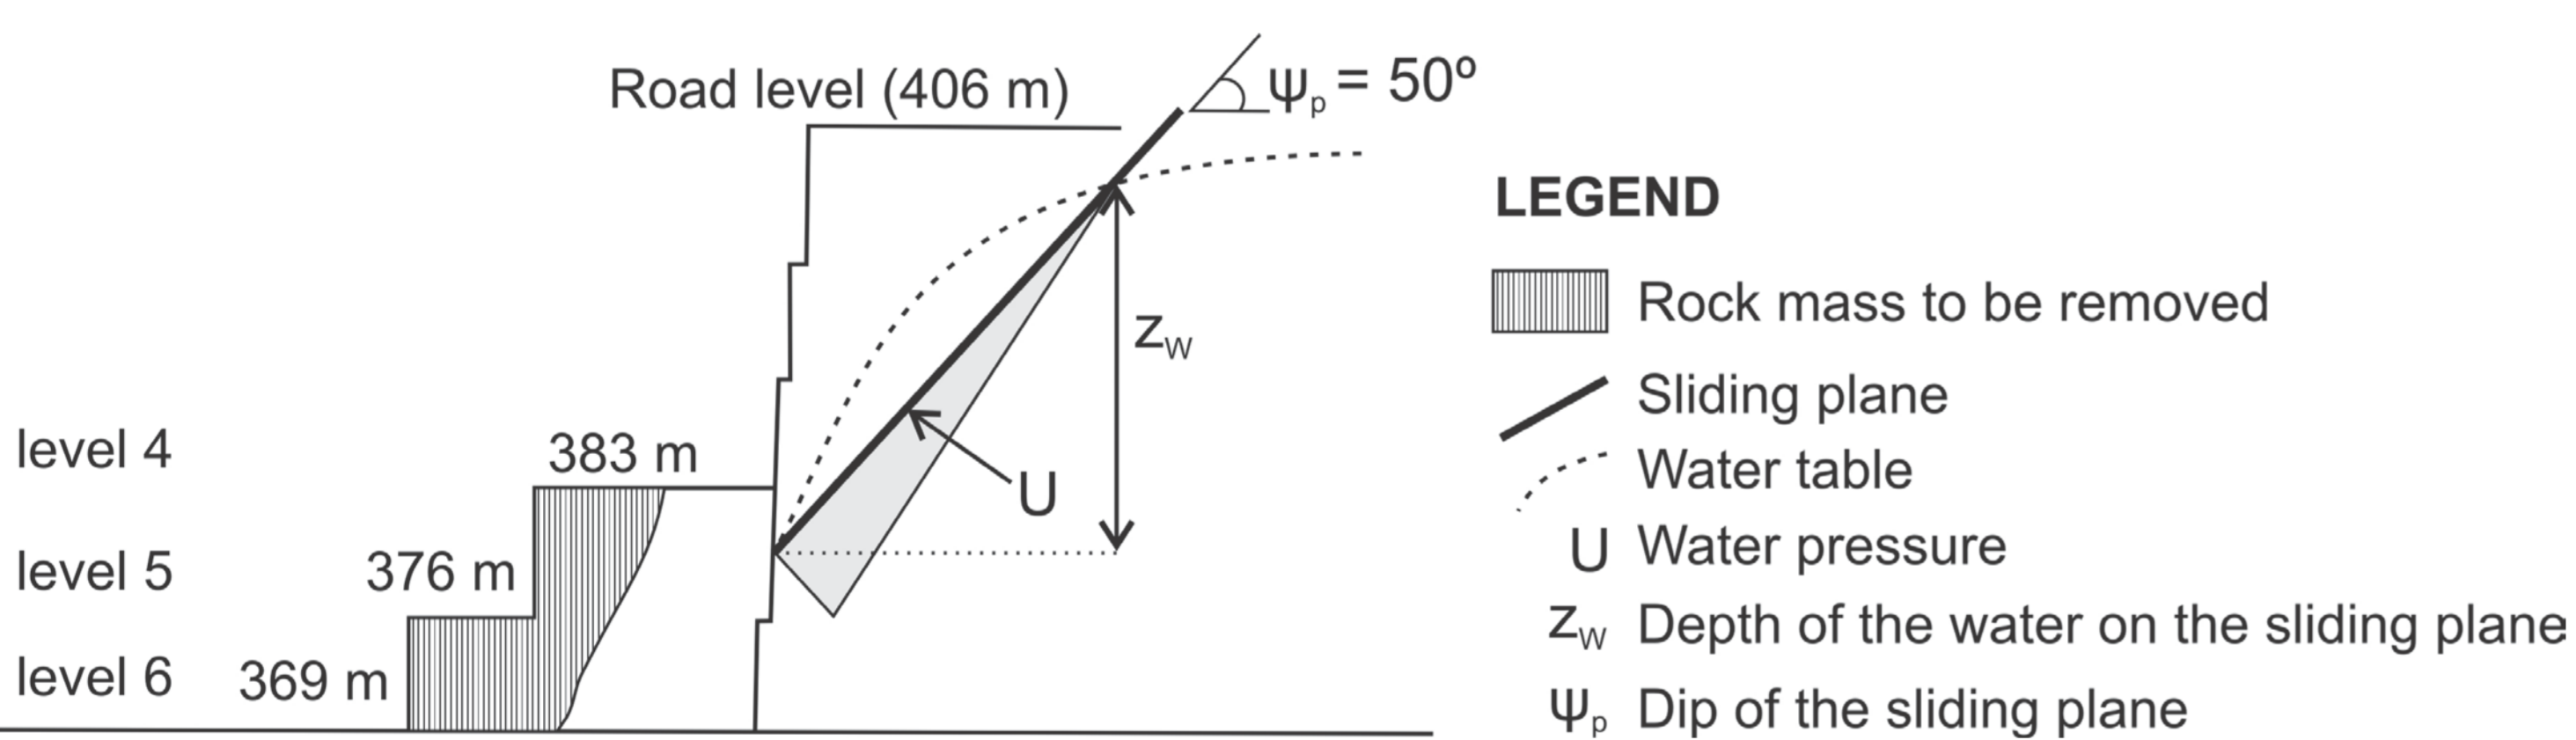
**Figure 7.** Geometry of the slope south of the quarry and types of acting forces.

The calculation of the **factor of safety** was accomplished by the method of limit equilibrium, using two-dimensional analysis for plane failure (Hoek & Bray, 1981), for a vertical slope section of unit thickness taken at right angles to the slope face, considering the following assumptions:

- In this two-dimensional analysis the role of the connecting surfaces to the slide are not considered.
- The action of vertical loads due to the movement of heavy vehicles loaded ( $W_2$ ). are considered in addition to the weight of the rock mass ( $W_1$ ). The value of 500kN/m was adopted.

- Vibrations were considered in the upper surface of the slope whether as a result of the movement of heavy vehicles on the National Road EN255, or as a result of the operation of the crane located in the top of the slope. It is considered that the combination of all those vibrations reach a value of one tenth of the acceleration of gravity.

- The presence of water on the sliding plane, considering the worst conditions for the stability of the slope, after the period of heavy rain.
- The probable reduction in the factor of safety to the removal of adjacent frontal benches to the slope, should be compensated through the installation of rock bolts.

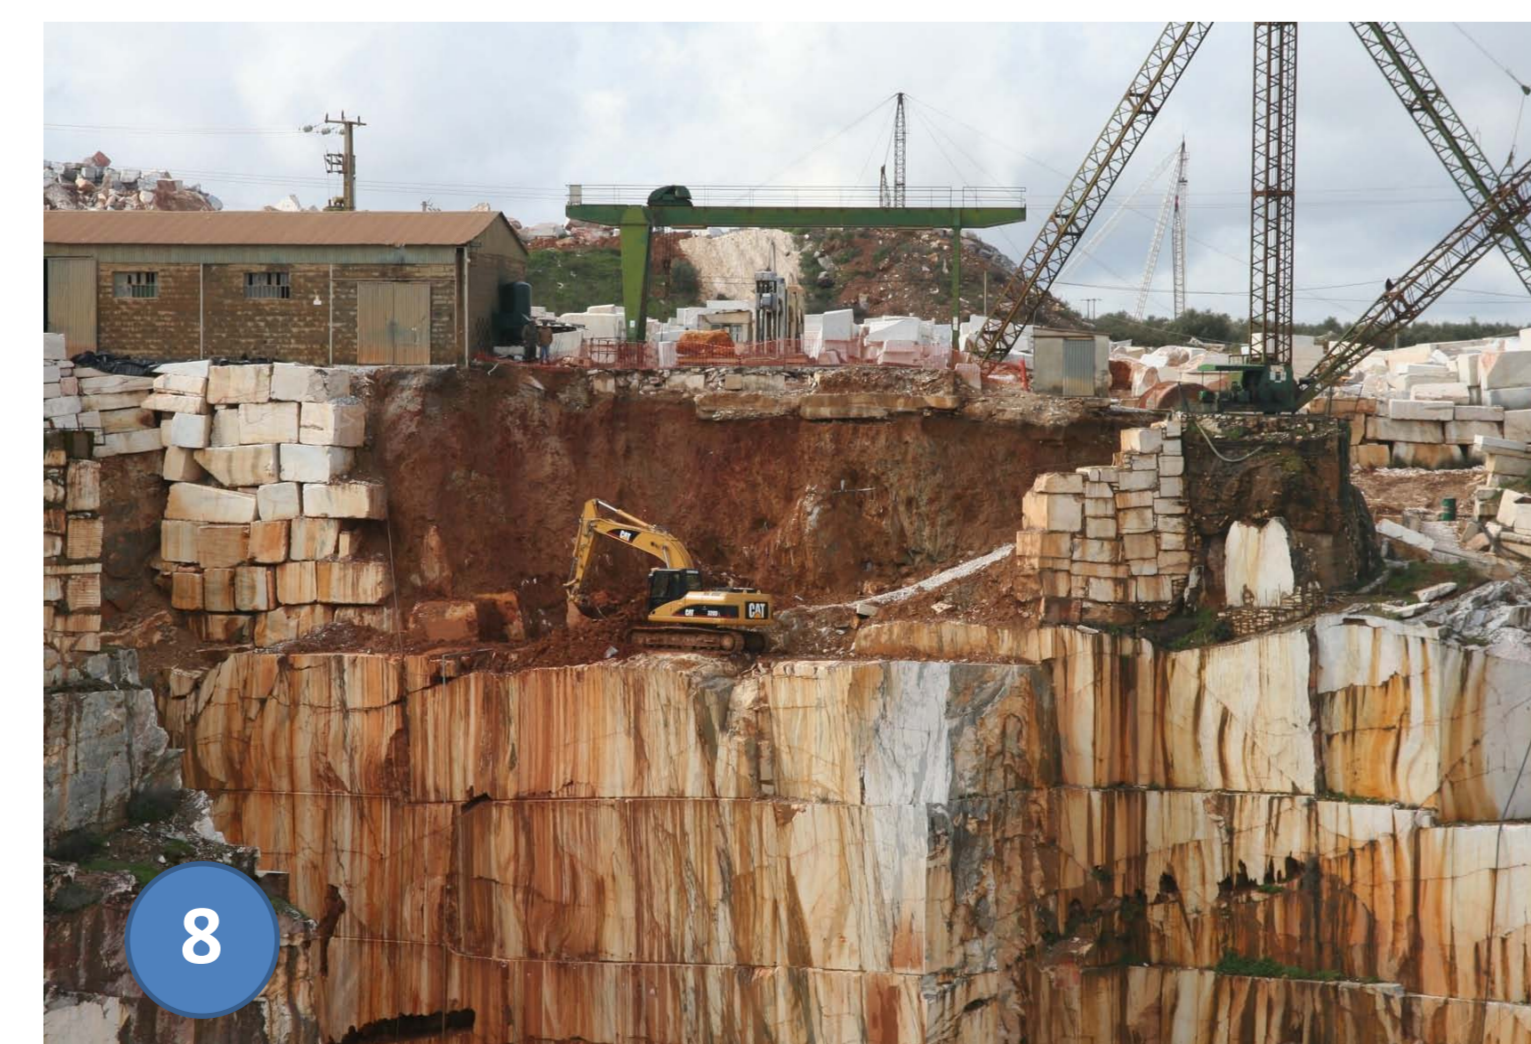
**Figure 8.** Example of procedure not appropriate of marble quarrying that can decrease the safety of people and cause material damage.

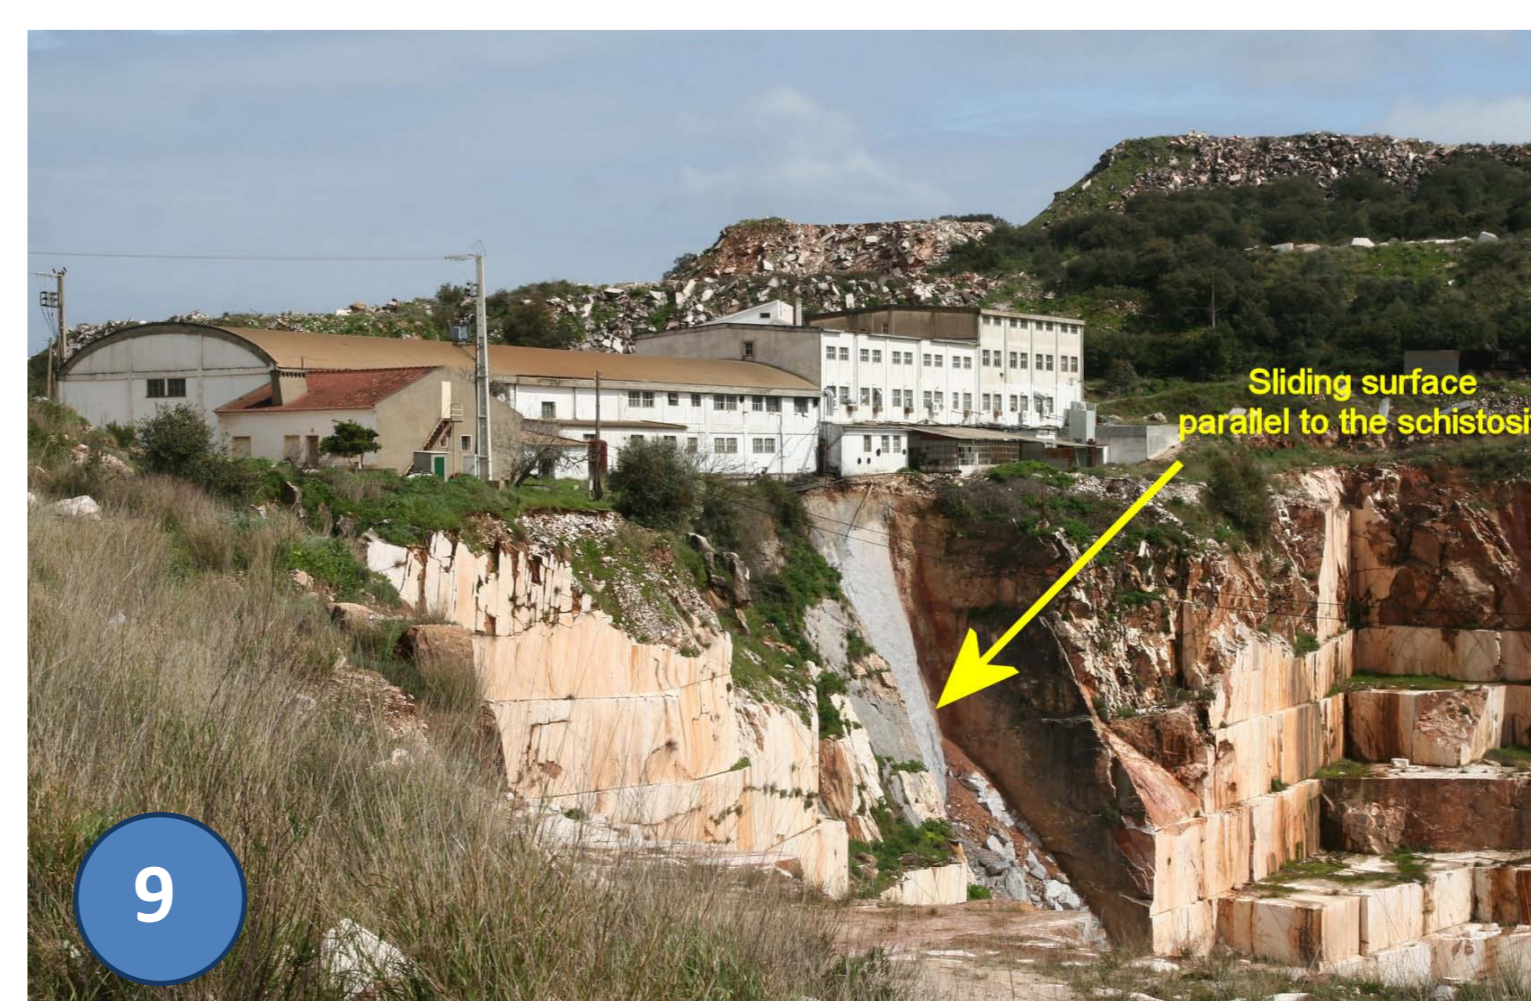
**Figure 10.** Aspect of an instability of a quarry slope, due to the fact that orientation of the quarrying is not in agreement with geological structure. This situation can be aggravated by the presence of water within the discontinuities (see picture inside), that contributes to increase the water pressure on the face of slope and, at the same time, decrease the shear strength of the discontinuities that occur in the rock mass.
