## Rock slope stability of the quarries of Estremoz marble zone (Portugal)—A case study

**ABSTRACT:** The Estremoz Marble Zone is one of the most important dimension stone production centre in the World. In these quarries located in the Alentejo Region (Southern Portugal), rock slopes, some of them with more than one hundred meters high, has been mined. This work emphasizes structural control in the marble quarrying and presents a case study, in which the analysis of the stability of a slope was based on a geological and structural data. The analysis was carried out in order to evaluate a possible failure of the slope due to the quarrying progress which could affect a surrounding quarry and a road close to the slope quarry.

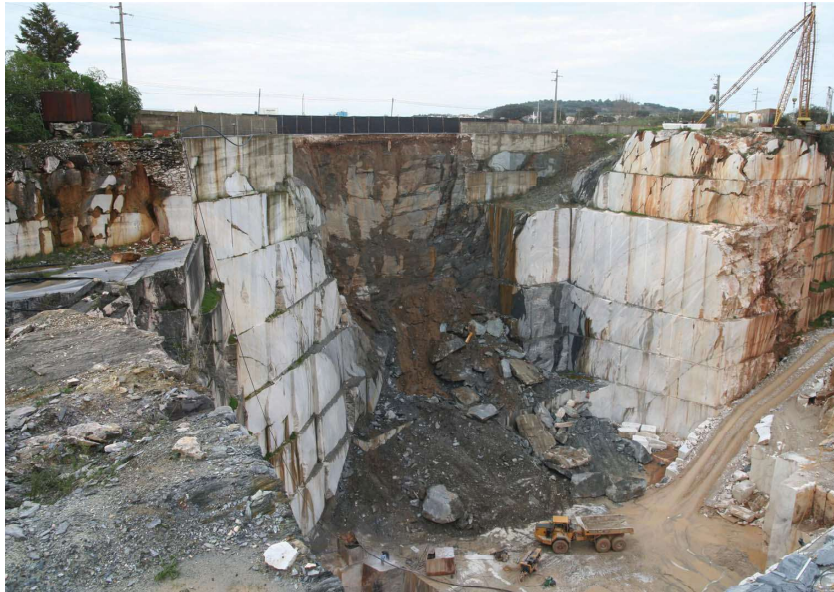
The case illustrated in Figure 2 (point 2 in Fig. 1), depicts a situation in which the preferred orientation of grains in the marble dips in the opposite direction to the dip of slope face. This fact would be adequate to ensure the stability of the slope, but a heavy rain period caused an abnormal accumulation of water within the discontinuities that contributed to increased the water pressure on the face of slope, and at the same time decrease the shear strength of the discontinuities that occur in the rock mass (preferred orientation of grains in the marble, joints, tension cracks, contacts between different lithologies, etc.). This situation induced instability due to the water infiltration causing the decrease in the effective strength due to increased pore pressure and the consequent rock fall. Fortunately there were no personal injuries to register. Although a thorough analysis has not been done it seems that the drainage and sealing the top of the slope could contribute to improve the slope stability. This example portrays very clearly the urgency of carrying out stability studies where similar situations are recorded.

Figure 2. Rock fall of the southwest slope of the quarry induced mainly by the effect of the water pressure within the discontinuities. This accident has also cut a road which profile is visible on the top of the slope. This quarry is located at point 2 in Figure 1.

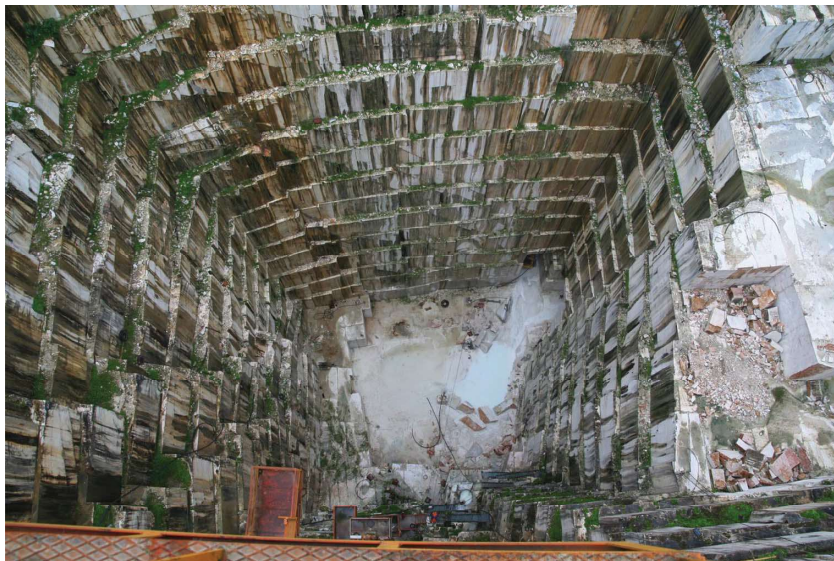
Figure 3. Vertical view of 120 m deep quarry, located in the southeast periclinal end of the geological structure. In the upper right at the bottom of the quarry can be seen the entrance of a gallery for the underground extraction of marble. This quarry is located at point 3 in Figure 1.

special significance (Fig. 3, point 3 in Fig. 1). The risks associated with the instability of the slopes are increased because it is a region of high seismic risk. Also, as in any carbonate rock region, there may be unknown phenomena of karstification depth. Figure 4 (point 4 in Fig. 1), illustrates a case where following a seismic event of 5.7 on Richter scale on 17th December 2009, subsoil movements led to the cavity represented.

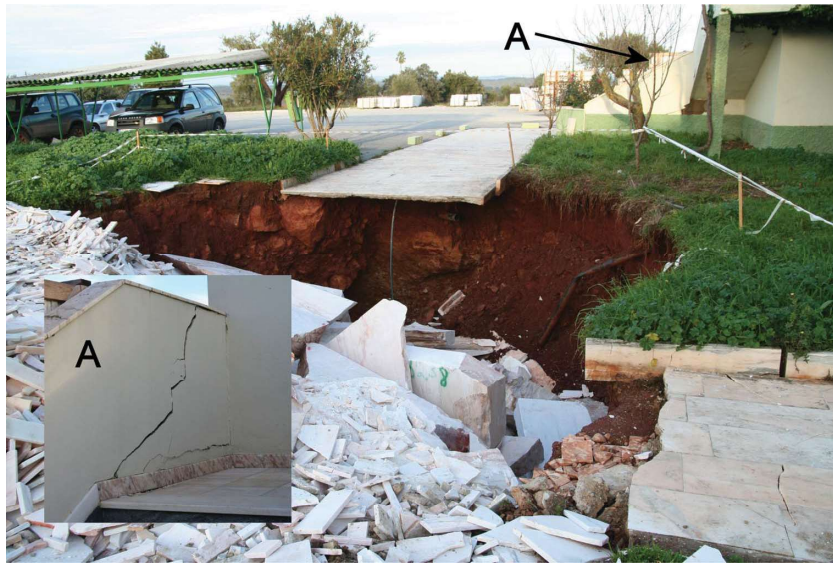
Figure 4. Karst cavity opened near a marble factory. This opening is probably related to a seismic event. This factory is located at point 4 in Figure 1.

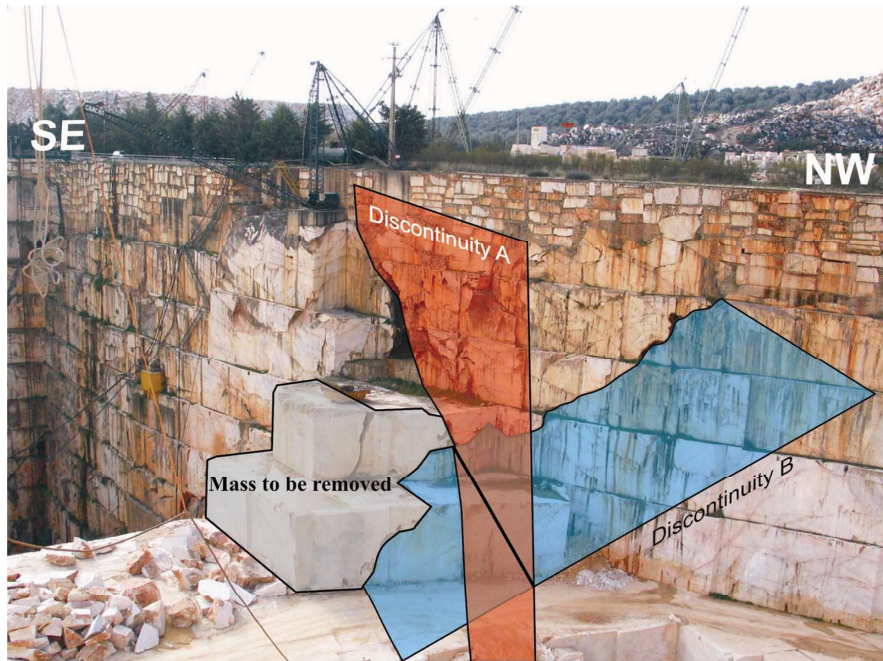
Figure 5. Southwest face of the quarry with the main discontinuities sets: A—open vertical discontinuity associated with karst cavity oriented N-S; B—planar discontinuity with orientation 50/072. The masses highlighted in gray are to be removed. This quarry is located at point 1 in Figure 1.

It should be referred the occurrence, in the southwestern slope of the quarry, a discontinuity that has a large karst cavity (discontinuity A), with an average N-S direction, vertical (see Fig. 5). The discontinuity A, belongs to a discontinuity set less common than the main discontinuity set B with which, in a first analysis, could lead to a possible wedge failure above elevation 381 m.

The analysis by stereographic projection of the planes of the two sets of discontinuities (A and B), concluded that the slope is potentially unstable but not all the conditions necessary for the occurrence of a wedge failure are verified, because in spite of  $\psi_f > \psi_i$ , is verified that  $\psi_i < \phi$ , ( $\psi_f$  being the dip of the slope face,  $\psi_i$  the plunge of the line of intersection of planes A and B, and  $\phi$  the friction angle of the line of intersection). Thus, the point that defines the line of intersection of the two planes lies outside the area enclosed between the circular arc defined by the slope face and the circle defined by the angle of friction. Moreover, the fact that the dip direction of plane B is much closer than the dip direction of plane A, to the dip direction of slope face, leads to the conclusion that the failure will be a plane failure along discontinuity B (Markland, 1972; Hocking, 1976).

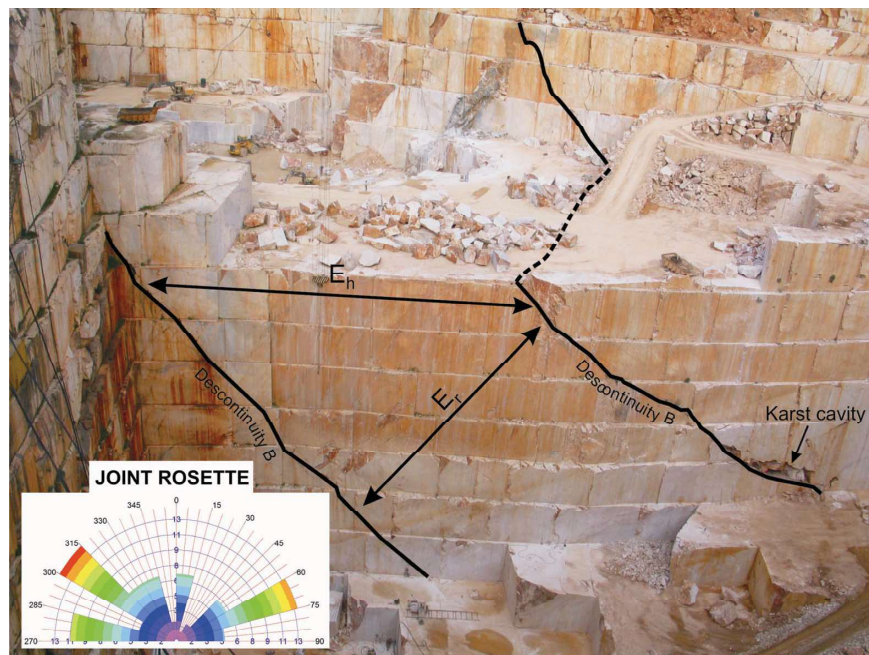
Figure 6. View to NW, which identifies the intersection of two discontinuities in set B. Horizontal ( $E_h$ ) and normal ( $E_r$ ) spacing are indicated, and despite being apparent they are very close to the actual spacings. On the right is possible to see the development of karst depth, which demonstrates the unpredictable nature of these structures. A joint rosette inserted shows the joint sets identified in the quarry. This quarry is located at point 1 in Figure 1.

The structural data obtained in the field were subjected to analysis and processing leading to its graphic representation contour pole density plots of the measured fractures, and as a joint rosette (see Fig. 6). The analysis of these diagrams reveals the existence of five major sets of discontinuities, but there is a marked dispersion around their geometric centres.

It should be pointed out that the discontinuity set of greatest significance in these diagrams, (joint set B) has a spacing of the order of tens of meters (Figs. 5 and 6), and also provide a greater lateral continuity or persistence. Another very important aspect to consider is the limited persistence of many discontinuities observed in the quarry faces. This results in low connectivity between the discontinuities which contributes to the stability of the slope. It appears that set B, with high persistence and spacing of the order of tens of meters has greater influence on the stability of the slope under study (Fig. 6). This set presents an inclination that varies between  $40^\circ$  and  $60^\circ$  to the northeast (with an average slope of  $50^\circ$ ) and an average dip direction of  $072^\circ$ , in other words, approximately parallel to the direction of the slope, which satisfies one of the fundamental conditions for plane failure (Hoek & Bray, 1981).

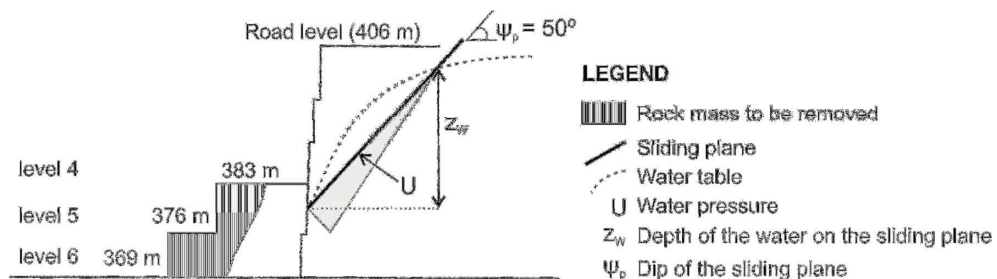
the water on the sliding plane  $z_w = 20$  m; the unit weight of water  $\gamma_w = 9.8$  kN/m<sup>3</sup> (see Fig. 7). Thus, we obtained:  $W_1 = 5739$  kN/m;  $U = 2942$  kN/m where  $W_1$  is the weight of the sliding block and  $U$  is the water pressure on the sliding plane.

In agreement with the suitable values of the several parameters for the most unfavorable situation (saturated slope), the factor of safety has a value of 1.29 which indicates unstable slope stability conditions even for a temporary slope. The slope under analysis must be considered a permanent slope according the existing physical constraints affecting the development of quarry mining and the National Road EN255 proximity. The safety factor calculated is lower than the recommended value for a permanent slope. However, as the water table is always below the bottom floor of the quarry, for mining operational reasons, originates favorable stability conditions due to the annulment of the water pressure along the sliding plane and therefore a value of 1.81 for the factor of safety is obtained, which indicates a good stability for the slope under study.

Figure 7. Geometry of the slope south of the quarry and types of actuating forces.

- iv. The presence of water on the sliding plane, considering the worst conditions for the stability of the slope, after the period of heavy rain.
- v. The probable reduction in the factor of safety to the removal of adjacent frontal benches to the slope, should be compensated through the installation of rock bolts.
