## Rock slope stability of the quarries of Estremoz marble zone (Portugal)—A case study

**ABSTRACT:** The Estremoz Marble Zone is one of the most important dimension stone production centre in the World. In these quarries located in the Alentejo Region (Southern Portugal), rock slopes, some of them with more than one hundred meters high, has been mined. This work emphasizes structural control in the marble quarrying and presents a case study, in which the analysis of the stability of a slope was based on a geological and structural data. The analysis was carried out in order to evaluate a possible failure of the slope due to the quarrying progress which could affect a surrounding quarry and a road close to the slope quarry.

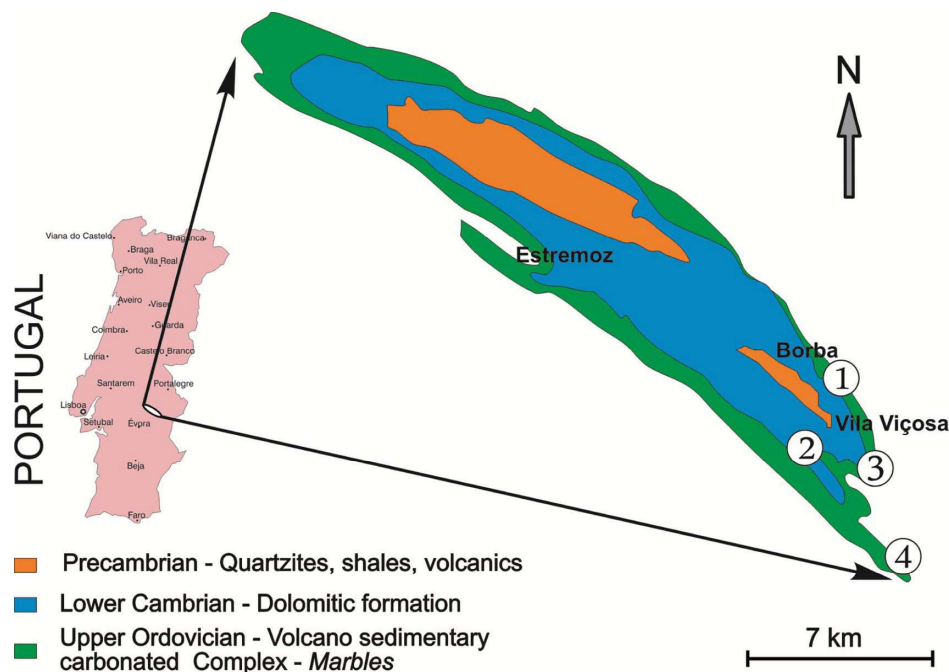
Figure 1. Geological sketch of the Estremoz anticline and point locations with references in the text. 1—Location of the case study. 2—Sliding in a quarry located in the southwestern flank of the anticline. 3—A 120 m deep quarry, located in the southeast periclinal end of the geological structure. 4—Karst cavity discovered as a result of earthquake, Alandroal.
